Manhole Inspection Summary

Manhole # S25I__004MH

Insp Date: **3/13/08 11:43 AM**

Location Address: **1224 West Lombard** Cross Street: **South Stockton**

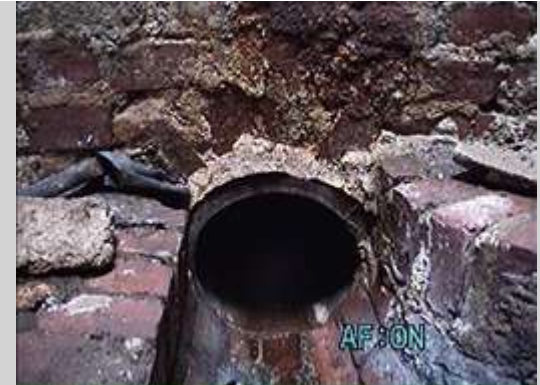
12 O'Clock Outflow

Pipe Height: **8.4** (in.) Rod and Bar (Angled)
Pipe Material: **Clay** ☐ Pipe Lined
Invert Depth: **9.80** (ft.) Flow Characteristics: **Slow**
Deposits: ☒ None ☐ Mud ☐ Sludge ☐ Debris ☐ Grease
Silt Depth: **0** (in.) Deposits Extent:
Infiltration: **None** Pipe Seal Cond: **Sound**

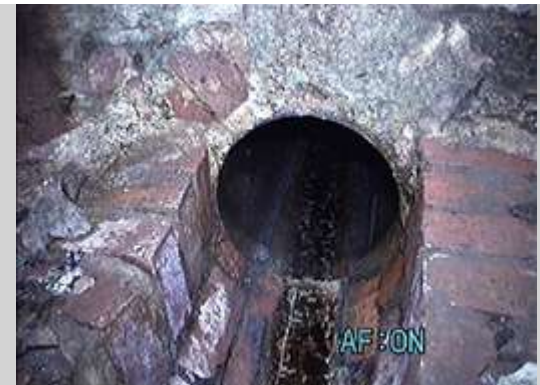
3 O'Clock Inflow

Pipe Height: **8.4** (in.) Rod and Bar (Angled)
Pipe Material: **Clay** ☐ Pipe Lined
Invert Depth: **9.35** (ft.) Flow Characteristics: **Slow**
Deposits: ☒ None ☐ Mud ☐ Sludge ☐ Debris ☐ Grease
Silt Depth: **0** (in.) Deposits Extent:
Infiltration: **None** Pipe Seal Cond: **Sound**
